# Manhole Inspection Summary

Manhole # S49AA\_031MH

**Inspection** ☐ Is Incomplete Rating: **4) Poor**

**Location** Address: **rear 600 n lakewood**

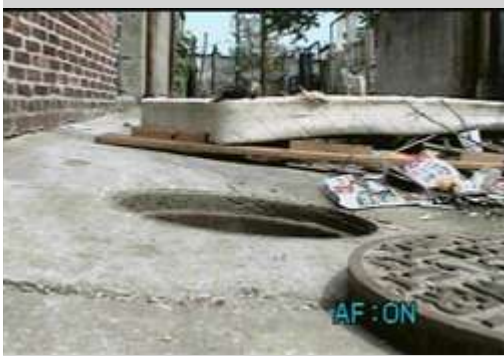
Location View

**Cover** Shape: **Circular** Diameter: **25.** (in.) Length: **0** (in.) Dist A/B Grade: **-1** (in.)  
**5**

inch below grade

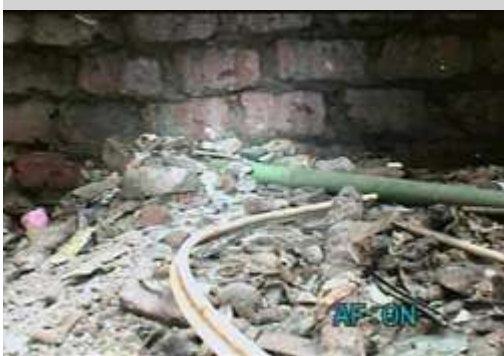
Defect 4

Condition: ☐ Sound ☐ Cracked ☐ Root Intrusion ☐ Deteriorated ☐ Leaks ☒ **Debris**

channel debris

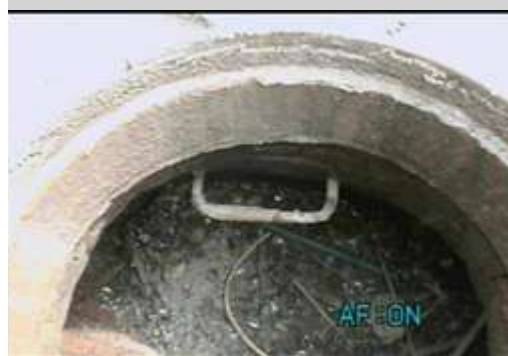
Defect 3

**Steps** Count: **1** Missing: **0** ☒ **Corroded**

step

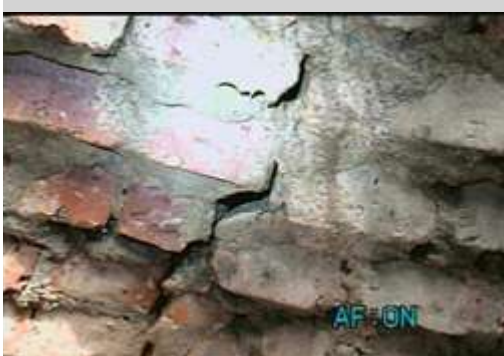
Defect 2

Condition: ☐ Sound ☒ **Cracked** ☐ Root Intrusion ☐ Loose Brick ☐ Deteriorated

cracked barrel

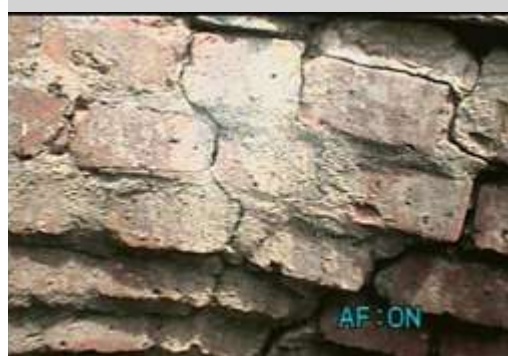
Defect 1

Condition: ☐ Sound ☒ **Cracked** ☐ Root Intrusion ☐ Loose Brick ☐ Deteriorated

cracked corbel
